Snow Country Ski Club

Smiggins Lodge Building Review

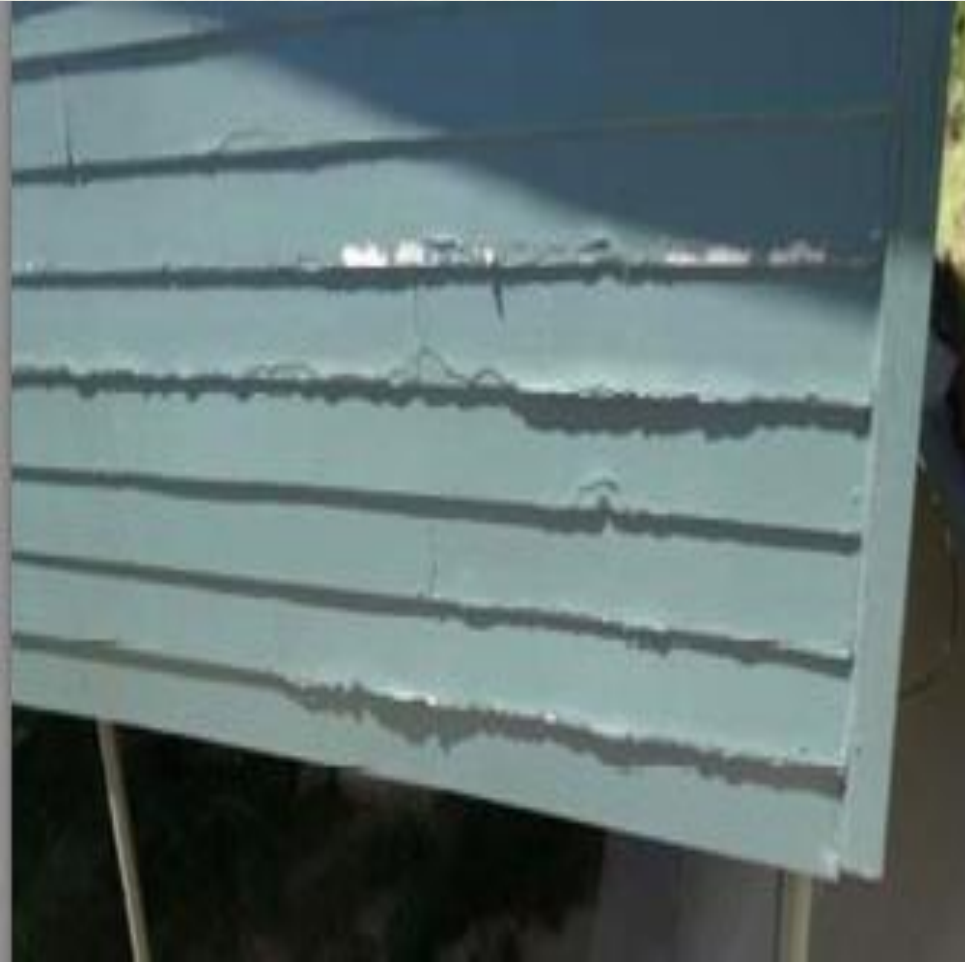
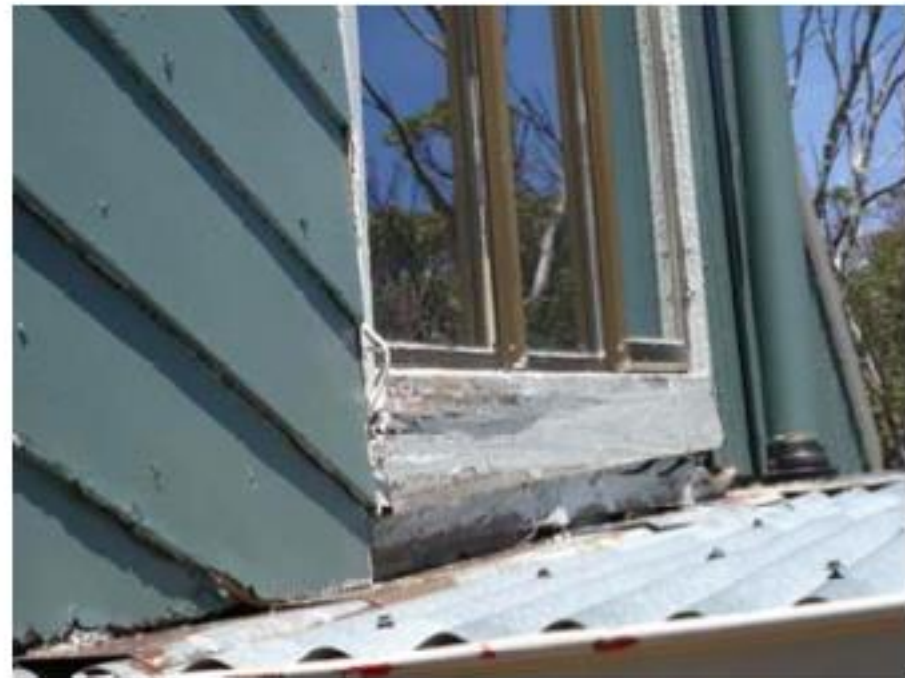
Damaged window trims/flashing causing leaks and rot

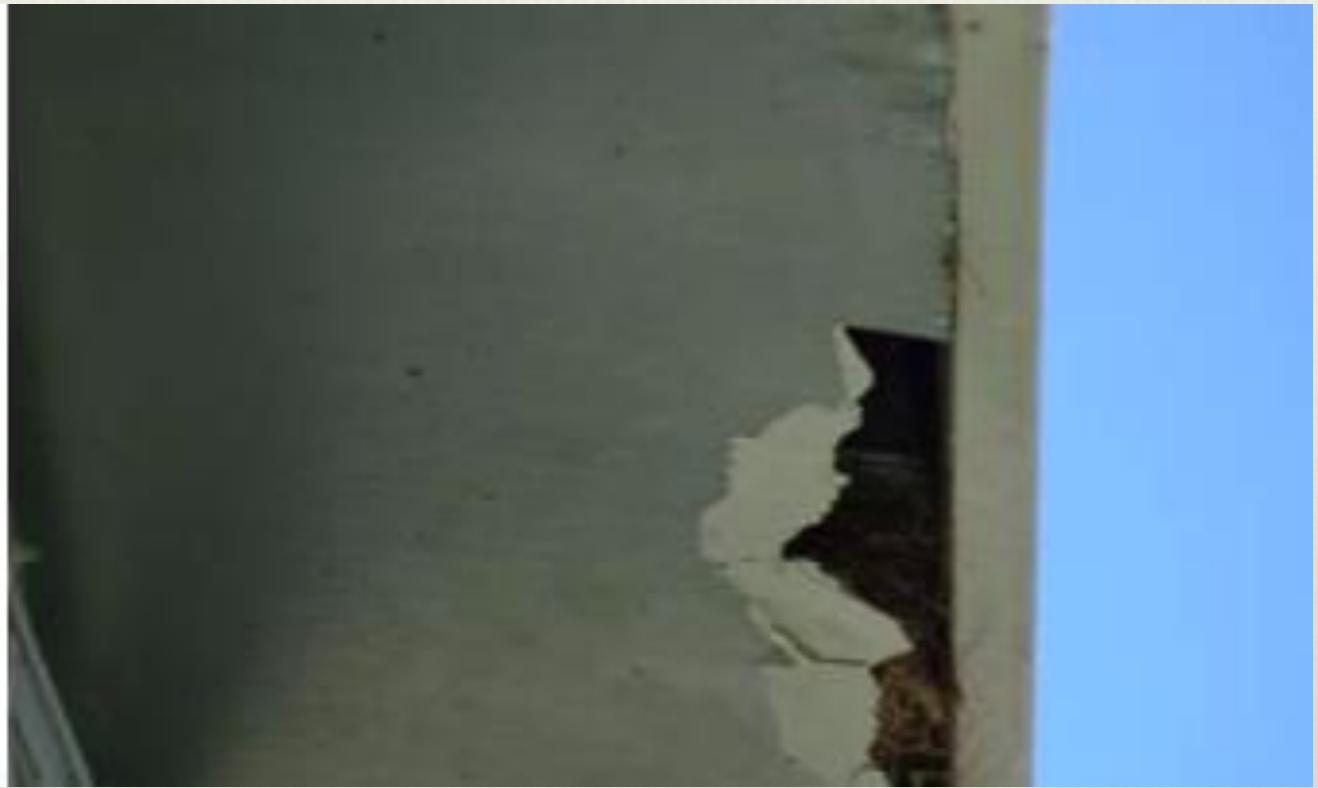
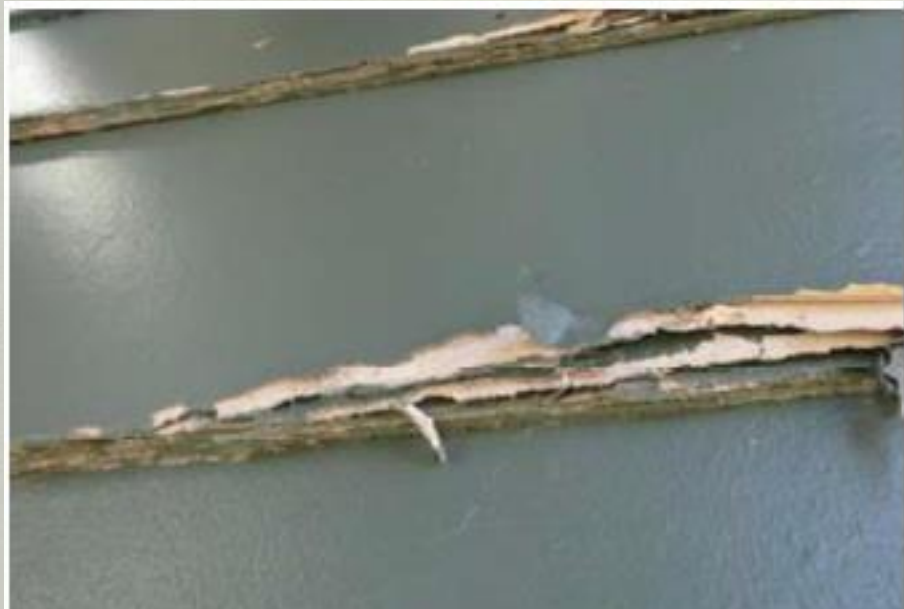
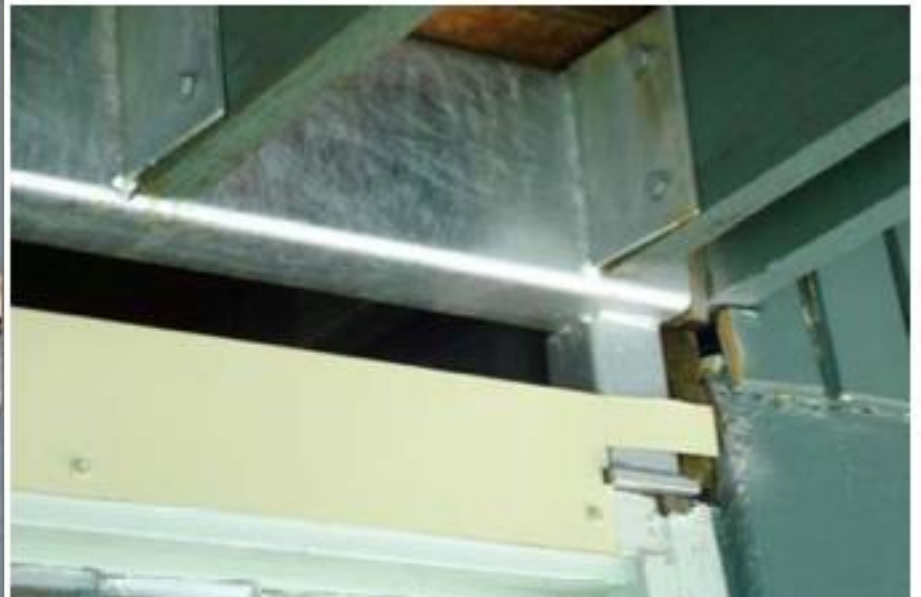
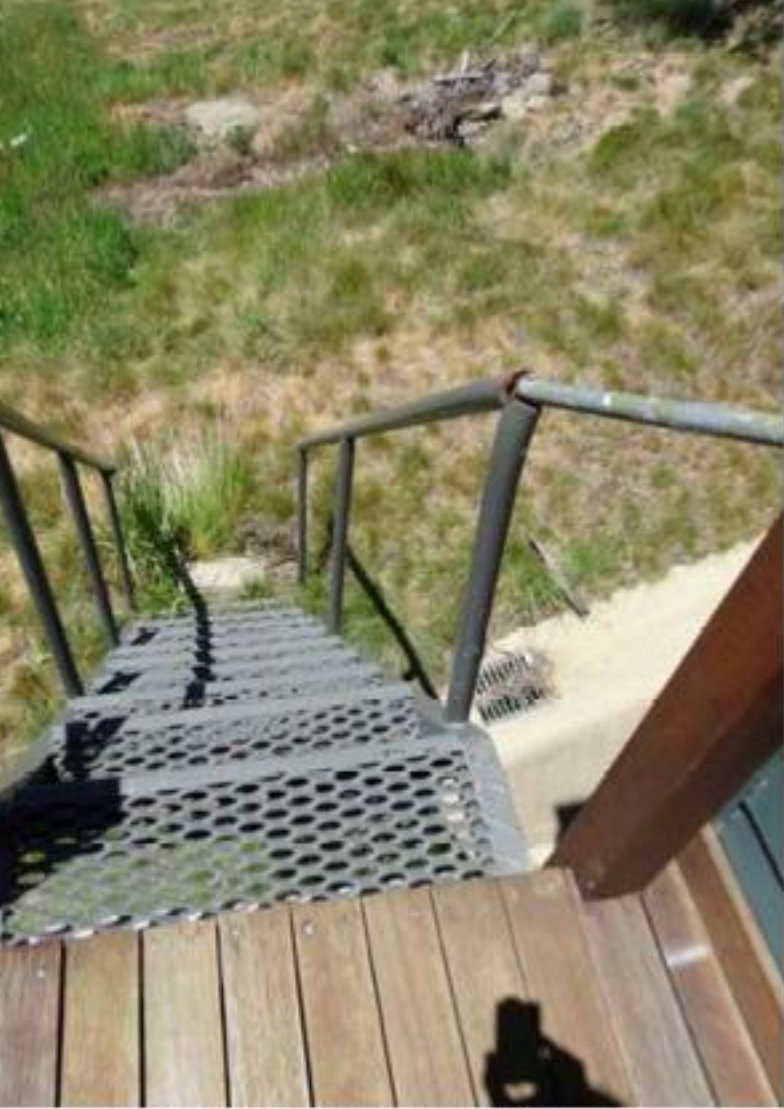
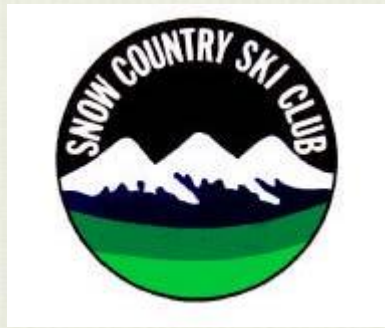
Significant
damage to eaves

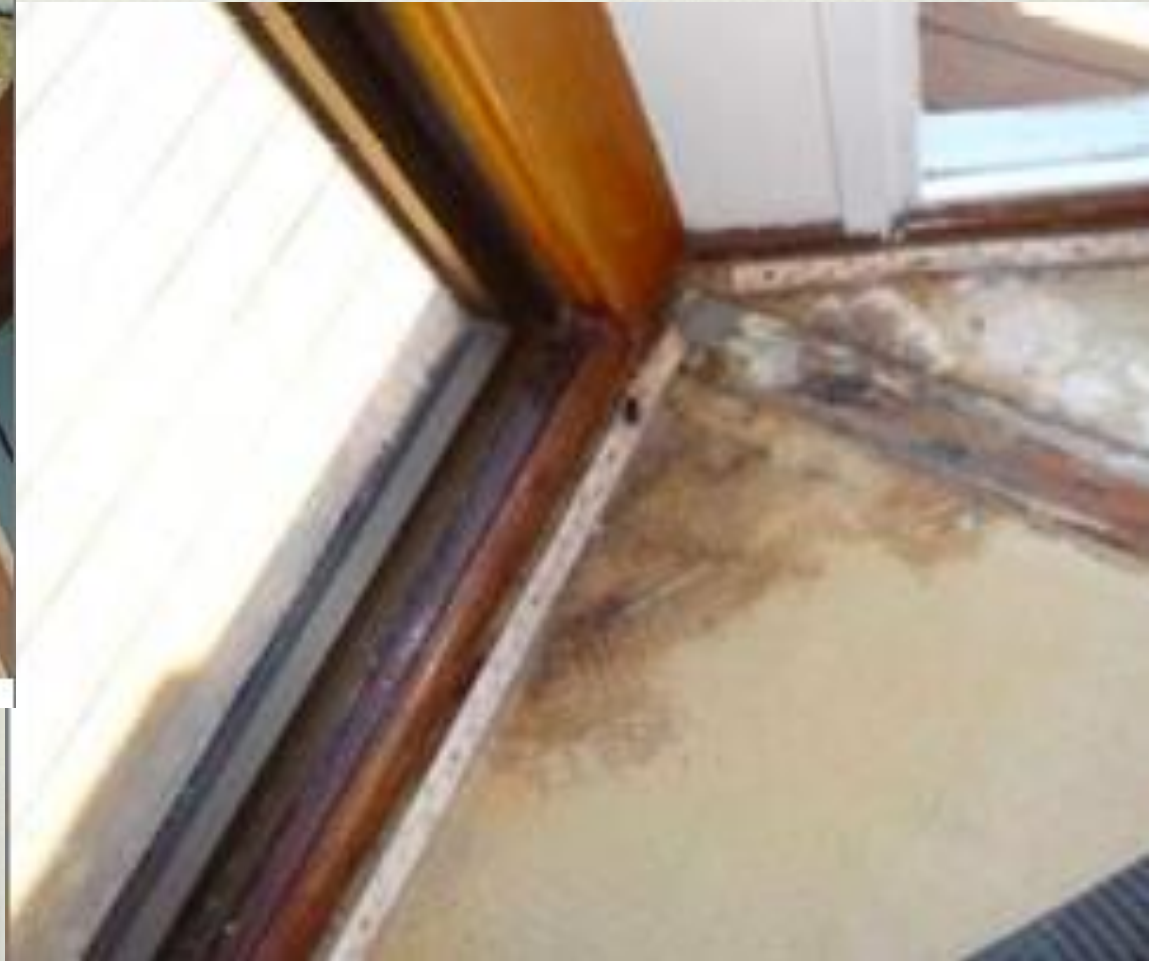
Water affected floors
due to leaking windows
